TECHNICAL REPORT 7711

EVALUATION OF A VAPOR COMPRESSION DISTILLATION UNIT FOR LAUNDRY WASTEWATER REUSE

US ARMY MEDICAL BIOENGINEERING RESEARCH and DEVELOPMENT LABORATORY

AUGUST 1977

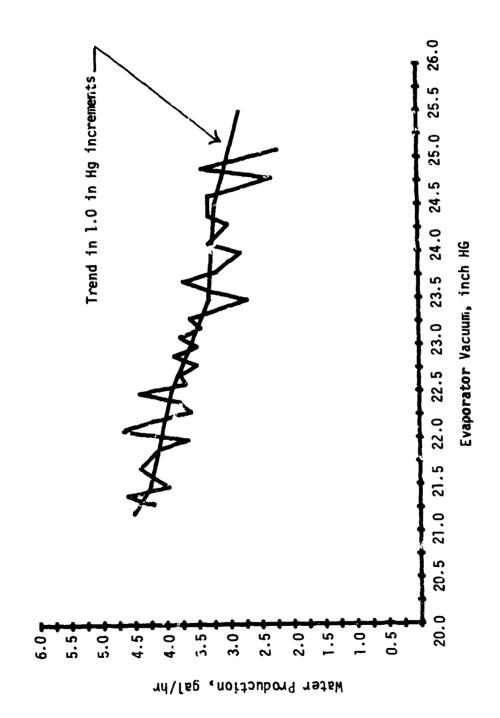
Figure 4. Evaporator Vacuum Versus Water Production.

Figure 4 is a plot of inches of mercury of evaporator vacuum versus production in gallons per hour. It illustrates a ragged but definite trend of increasing production with vacuum decrease as would be expected according to the design of the unit. Average production realized over an inch of vacuum is also plotted, which smooths out the trend. It shows a gradual, fairly constant trend of increasing production approximately 0.3 to 0.4 gallons per hour with each inch of vacuum decrease. It was

felt that higher production could have been obtained at lower vacuums, however the compressor motor is not designed to bear the higher pressure load and would have been shut off by its high pressure switch.

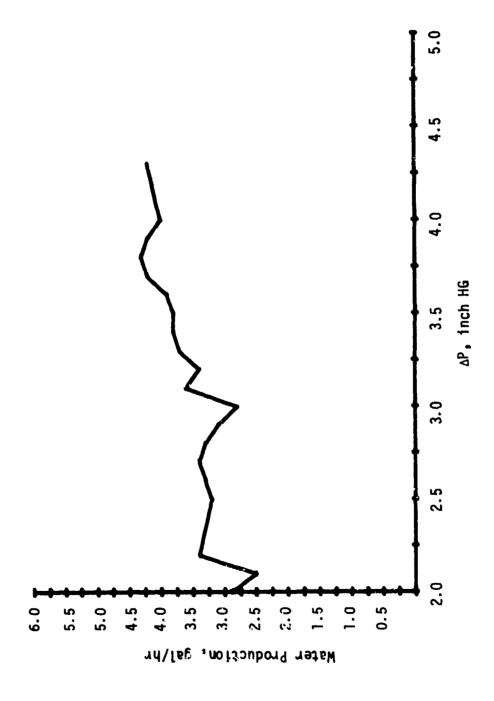
Difference Between Condenser and Evaporator Vacuums (ΔP) Versus Mater Production. Figure 5.

Figure 5 is a plot of ΔP in inches of mercury versus production in gallons per hour. The ΔP was defined earlier as the difference between evaporator and condenser vacuums with the latter always smaller than the former. Figure 5 also shows a gradual trend, in this case, of increasing production with increasing ΔP . Design of the VCDU is predicated on 2 inches of mercury difference, but during the operation 3 to 4 inches were experienced.

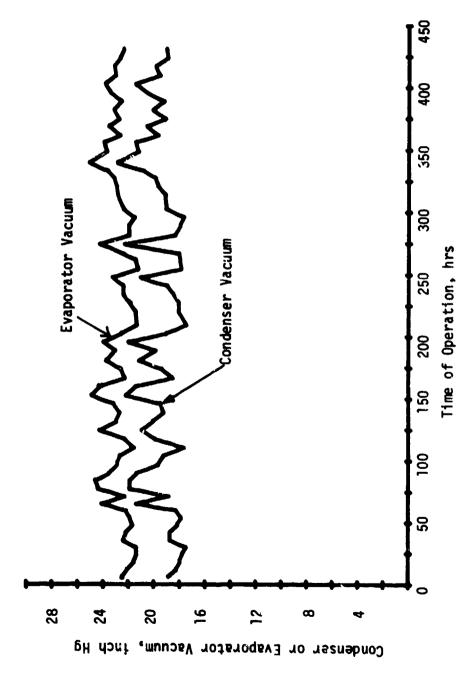
Figure 6 complements Figure 5. It is a plot of the average daily condenser and evaporator vacuums as the run progressed. The condenser and evaporator vacuums follow one anothers high and low average daily values closely. Further scrutiny of the figure and further analyses of the data show that their difference (ΔP) is greatest when the vacuum values are low, compared to when both condenser and evaporator vacuums are high. VCDU operation reached steady state and experienced best production at the "low" 21 inches mercury of evaporator vacuum.

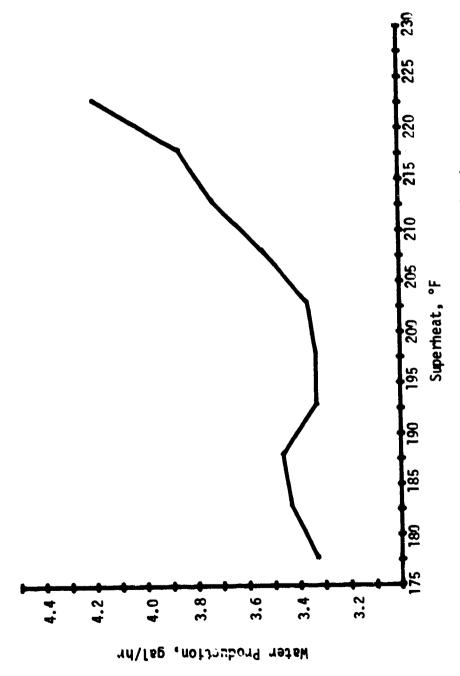
Figure 7. Superheat Versus Water Production

Average daily production was found for each 5°F increment of superheat. A running average spanning 15°F and moving up in 5°F increments was then plotted versus production (Fig. 7). Significant in the figure is the dramatic increase in production rate after 205°F. During operation of the VCDU, the superheat was observed to fluctuate first and give the earliest indication of operational changes. It functioned in a passive role, a result of VCDU operation, rather than in an active role as was the evaporator vacuum.

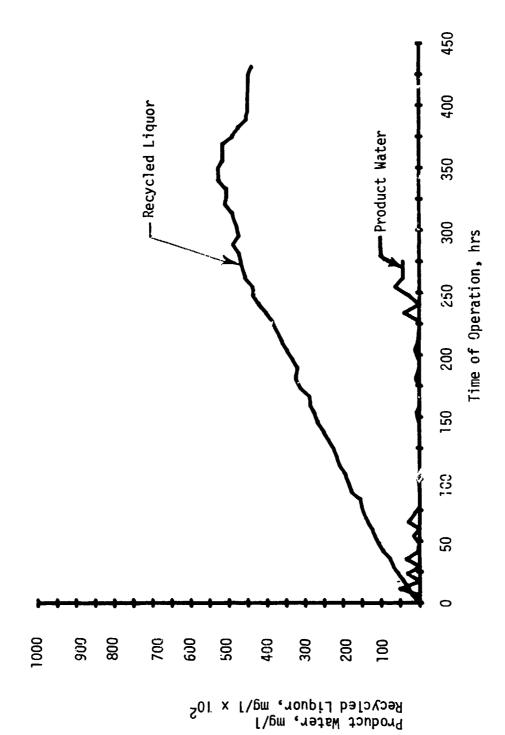
Recycled Liquor and Product Water Total Solids Versus Time of Operation. Figure 8.

The first indication of atypical operation occurred approximately 275 hours into the run at a recycle liquor solids content of 4.7 percent. There was a sudden drop in the superheat. Samples of the product water taken when superheat was low showed a definite increase in total solids. Time periods of low superheat processing with the accompanying decrease in product water quality became more and more frequent until 349 hours into the run when solids carry-over from the recycle liquor into the product condensate became so frequent that the liquor total solids content began to decrease.

Figure 8 is a plot of product water and recycle liquor total solids content. Total solids in the latter reached 5.3 percent before they

began to decrease. VCDU processing continued to 432 hours to verify the trend. Prior to 275 hours into the run, daily product water solids content normally ranged from 0 to 15 mg/l with random exceptions measuring as high as 63 mg/l. After 275 hours the quality of the product water depended on whether one sampled when the superheat was low or high. Defining superheat to be low when it was < 180°F, (hourly measurements recorded as low as 150°F), total solids measurements ranged from 491 to 2,167 mg/l and averaged 1,301 mg/l. During "high" superheat sampling, solids measurements of the product water ranged from 78 to 470 mg/l and averaged 193 mg/l - poor compared to the solids content experienced prior to 275 hours of operation. Conductivity of the product water was also measured and followed total solid trends. Measurements made after 275 hours are not plotted in Figure 8 because of the subsequent irratic values.

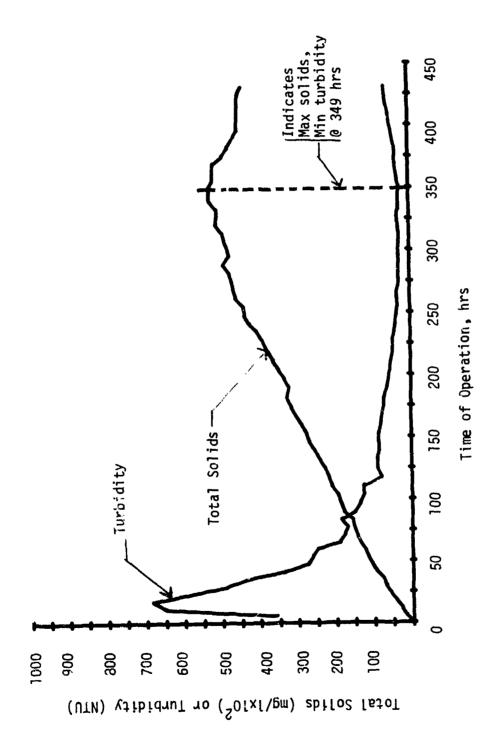
Recycled Liquor Total Solids and Turbidity Versus Time of Operation. Figure 9.

Figure 9 is a plot of recycled liquor total solids and turbidity as the run progressed. The turbidity values decrease even as total solids increase. This was a surprising trend and it indirectly characterizes the nature of the liquor. The fact that soap will readily combine with ions in solution including iron from the VCDU and tend to precipitate out was considered, but rejected as not the case. The recycle line is near the bottom of the processor and the sample port is in the recycle line. Contents of the samples were well mixed. Rather, it is the nature of the floc, which, although opaque to the eye, exhibited diminishing light scattering characteristics over time, ostensibly because of the constant mixing through the centrifugal recirculation pump and even though total solids were increasing. Interestingly, turbidity of the recycle liquor began to increase after 349 hours of operation, at the same time the total solids began to decrease. A line is drawn through this time to accentuate the trend. It is not known whether this trend is a coincidental or a characteristic relationship between the total solids and turbidity. Measurement of suspended solids would be desirable for future study.
